Service Letter

SL02-412/NIM
December 2002

Fuel Pump Top Cover
L/S35MC, S46-50-60-70MC-C
(Fuel pumps without VIT)
Action Code: AT FIRST OPPORTUNITY

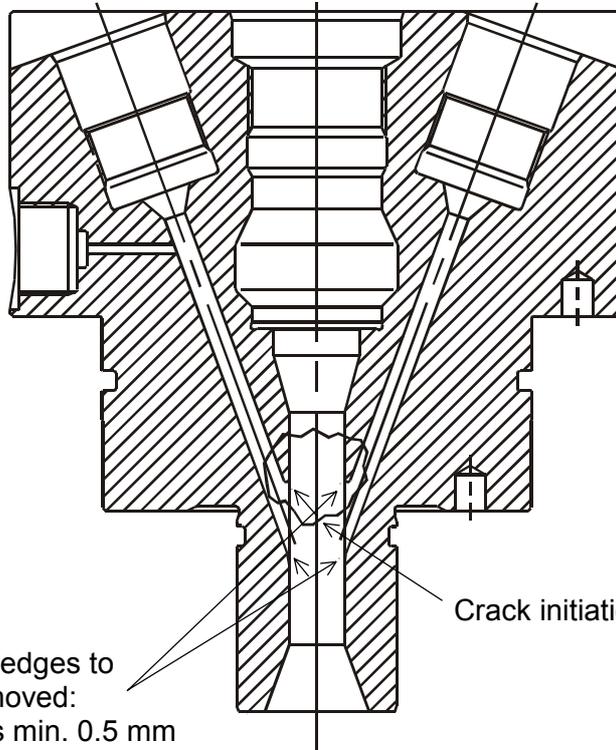
*Fig. 1:
Previous design*

The cracks are initiated at the edge between the central bore and the inclined bores, due to the lack of the specified manual finishing of the transition edge between the central bore and the inclined bore. The crack-initiated area is shown in Fig. 1.

We have noted that, in each case, the crack has developed into the bore for the suction valve, whereby high-pressure fuel is pumped into the low-pressure chamber. This reduces the fuel injection pressure, and the alarm for low exhaust gas temperature will be sounded so that the crew has the possibility of correcting the failure. We have not received any reports of cracks developing in such a way that fuel leaks out into the engine room.

Crack initiation area

We recommend checking whether the spare cover is of the original design. If this is the case, please check the transition between the vertical bore and the inclined bores. The transition area must have a radius of min. 0.5 mm. On the spare top cover, the sharp edge must be removed and a rounding of min 0.5 mm must be made.

We consider that removing the sharp edge, as described, will rectify the cover, thus we recommend that you keep two spare covers on board.

Sharp edges to
be removed:
Radius min. 0.5 mm

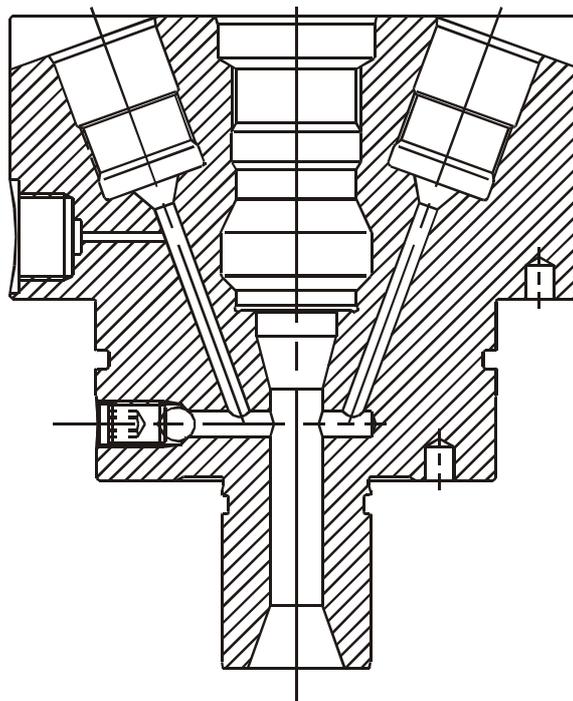
*Fig. 2:
Modified design*

In order to eliminate the need for manual finishing during production, and as an alternative to this, we have introduced a modified design for future top covers. The design is shown in Fig. 2.

The modification involves the introduction of a horizontal bore connecting the vertical central bore and the inclined bores.
