Service Letter

SL07-474/JJP
March 2007

Lifting Tool for Crosshead Bearing Cap 80-98MC/MC-C and ME/ME-C Engines

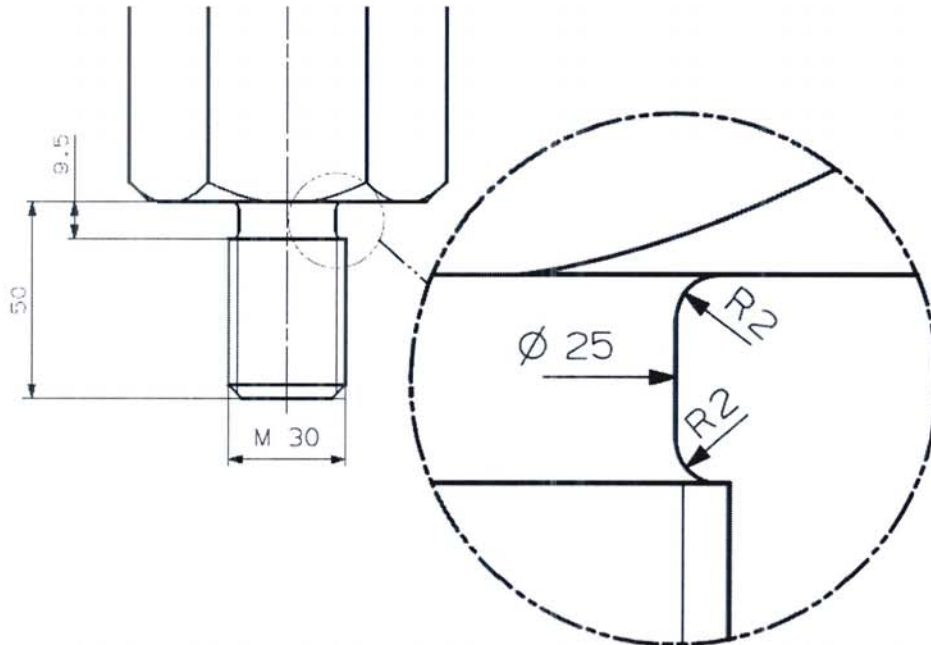
Fig. 1: Lifting tool for K98MC-C

The stud has not been made from adequate material and, equally important, it appears not to have been machined as specified. One important fillet was smaller than specified. Furthermore, the thread tap on the extension tool seems to have been pre-bent from an earlier lift.

We recommend engine crews to check the fillets on the lifting tools, see Fig 1.

If an insufficient fillet or signs of cracks, bending or other misuse is found, we strongly recommend to discard the extension stud and order a new one, either from the engine builder or from MAN Diesel A/S, PrimeServ in Copenhagen.

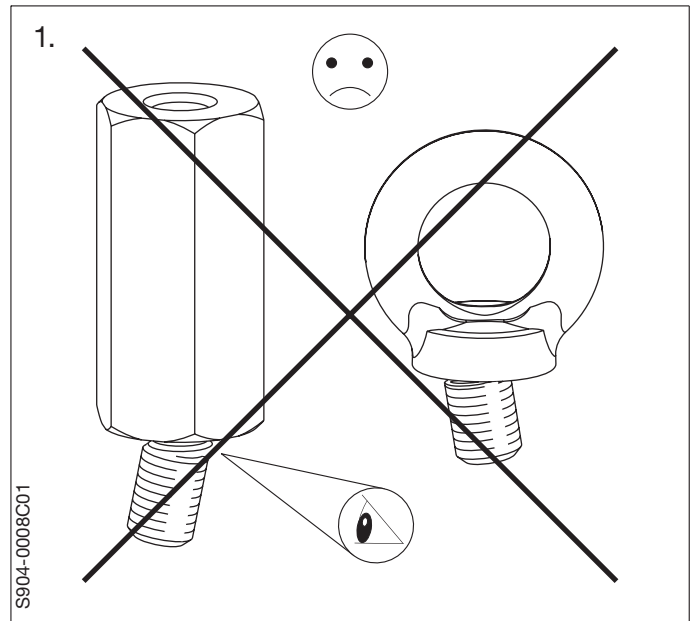
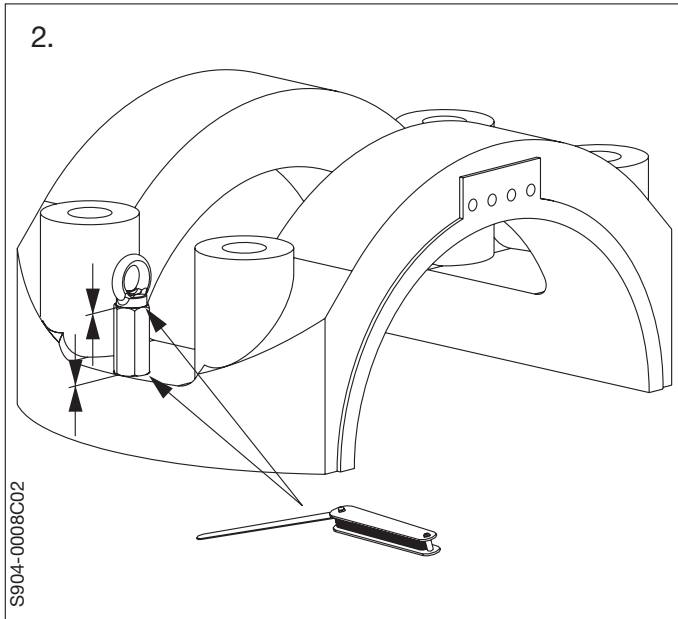
Extension studs or eyebolts which show signs of overload or misuse must **NOT** be used. Lifting components which shows signs of bended threads or cracks must be discarded and new parts must be ordered.

2. When fitting the extension studs and eye-bolts make sure to tighten to face contact.

Check with a 0.05 mm feeler gauge that there is no clearance between the lifting tools and the face.
