Spark Erosion Update

August 2008
SL08-498/AAB

Owners and operators of all MAN B&W two-stroke marine diesel engines.

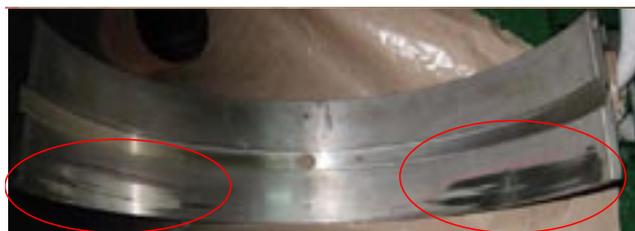
Upper main bearing shell

AlSn40 Lining

This is a journal, main bearings and thrust collar with clear signs of spark erosion. Spark erosion signs are obvious, even in the upper main bearing shell.

The bearing damage is irreparable: This bearing cannot be re-used, it has to be replaced.

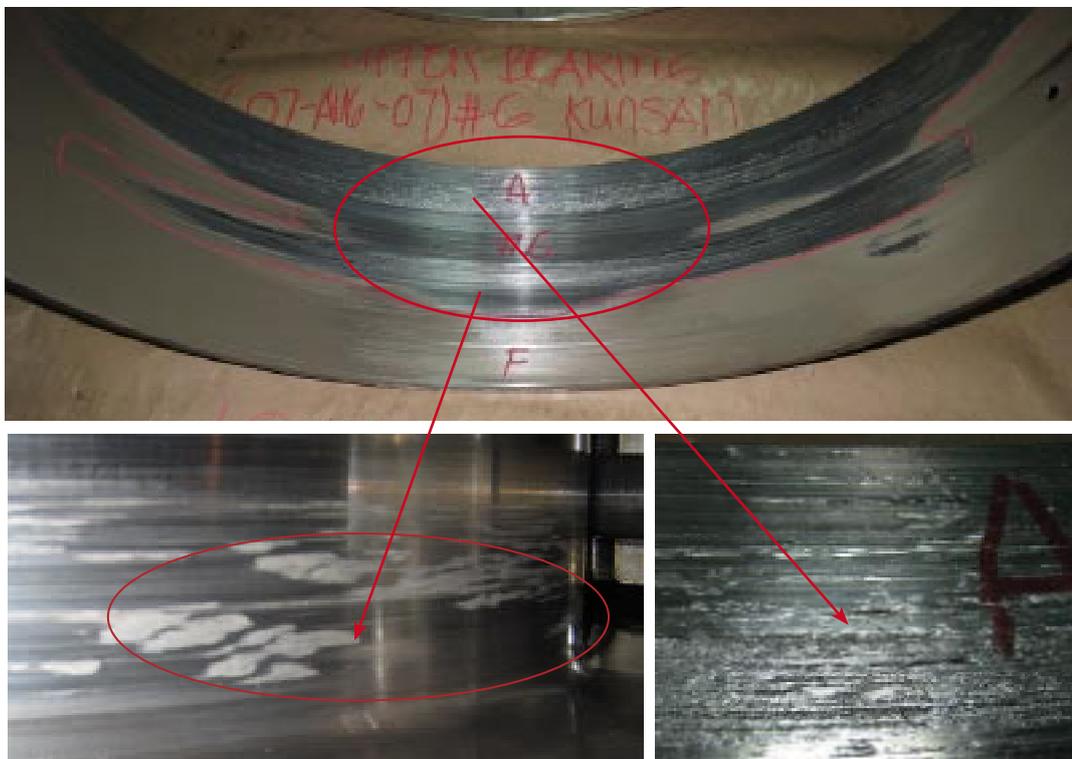
This journal **MUST** be polished to meet surface roughness specifications.

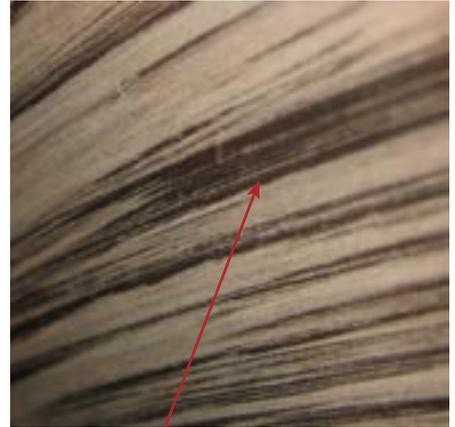
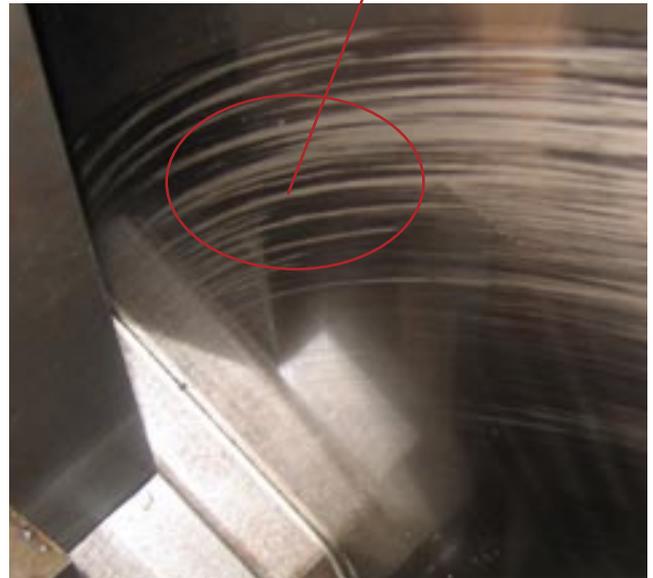
Thrust Collar Face

This is a thrust collar face with clear signs of spark erosion. Spark erosion may not be visible on the entire surface.

The greyish stripes on this thrust collar face indicate spark erosion

When inspecting the thrust collar surface or the main bearing journal, remember:
Slowly turn the engine 360°/1 revolution, and inspect the entire surface very carefully.

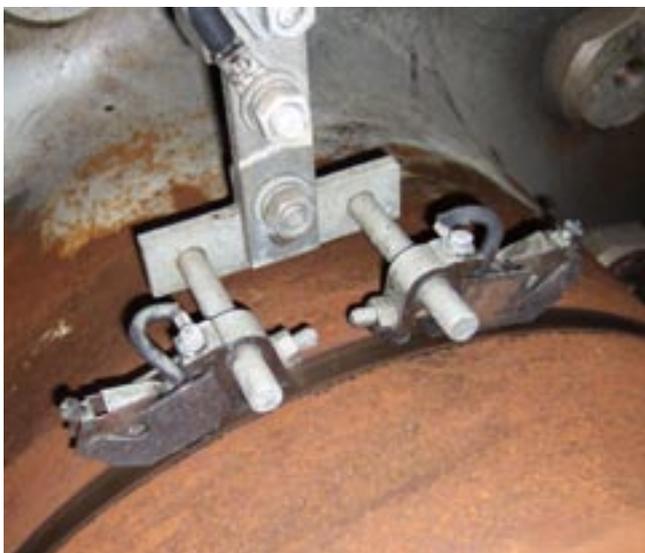
No seperate slip ring installed

No Slip Ring

2-year-old vessel, incorrect installation.

Here, the carbon brushes run directly on the propeller shaft, and so electrical contact between brushes and shaft is reduced.

- Install a silver covered slip ring between the brushes and the shaft to ensure sufficient electrical contact
- Replace the slip ring before the silver layer is worn through.
- Inspect brushes regularly, and re-adjust brushes when necessary.

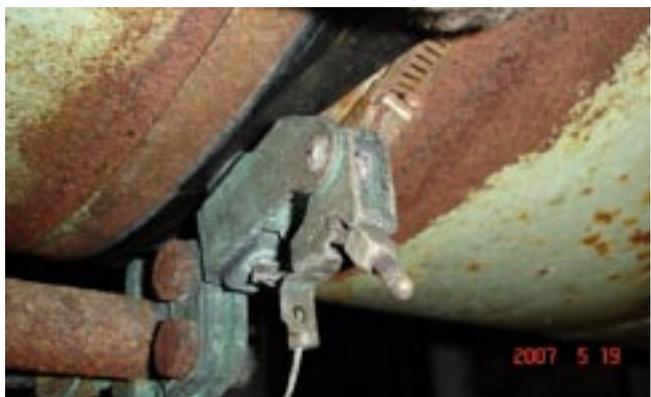
Poor hardware quality

Poor Hardware Quality

3-year-old vessel, incorrect installation.

These pictures show a severe rust attack causing poor contact between the slip ring and the shaft. The installed cables are incorrectly dimensioned. Cables, Ag/carbon brushes, and slip ring are of poor quality that do not meet MAN Diesel specifications.

ALWAYS install slip ring, cables and brushes that meet MAN Diesel specifications (see appendix for details).

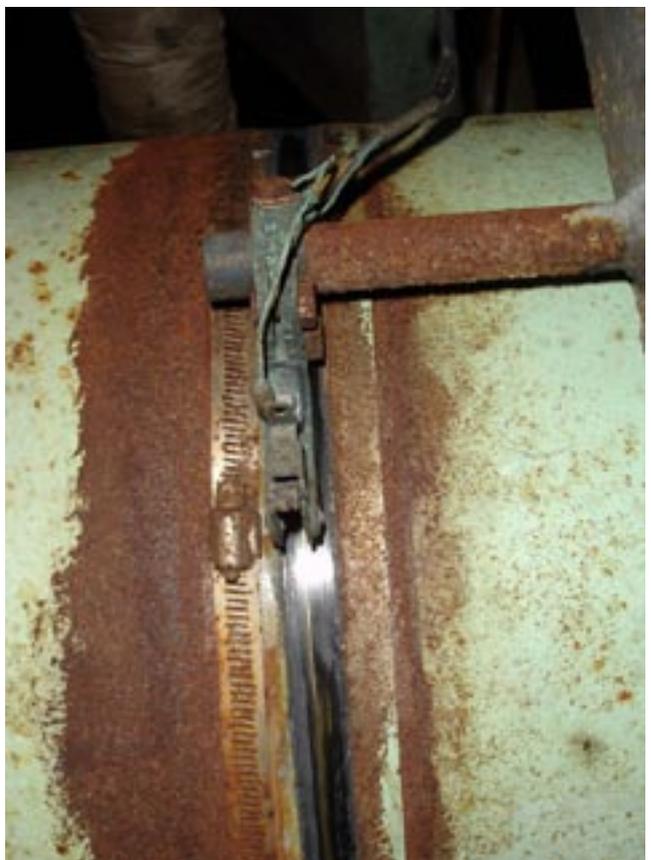
Brushes and cables that do not meet MAN specifications

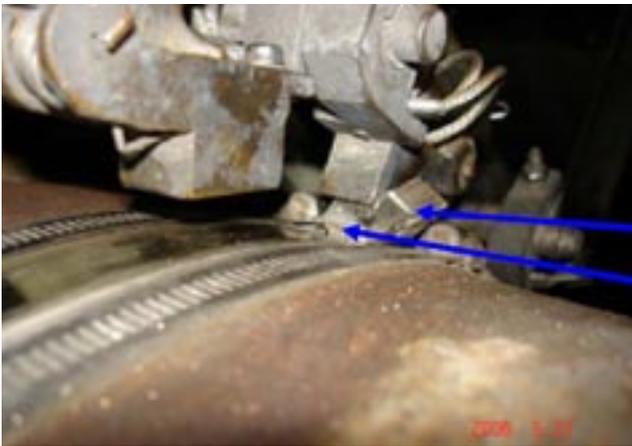
Poorly adjusted brushes

Poor Brush Adjustment

This picture shows a set of incorrectly adjusted brushes. The brushes have slipped out, and so the distance between brushes and slip ring is too long.

- Inspect the brushes if the voltmeter reads more than 50 mV.
- Re-adjust the brushes if they have insufficient contact with the slip ring.

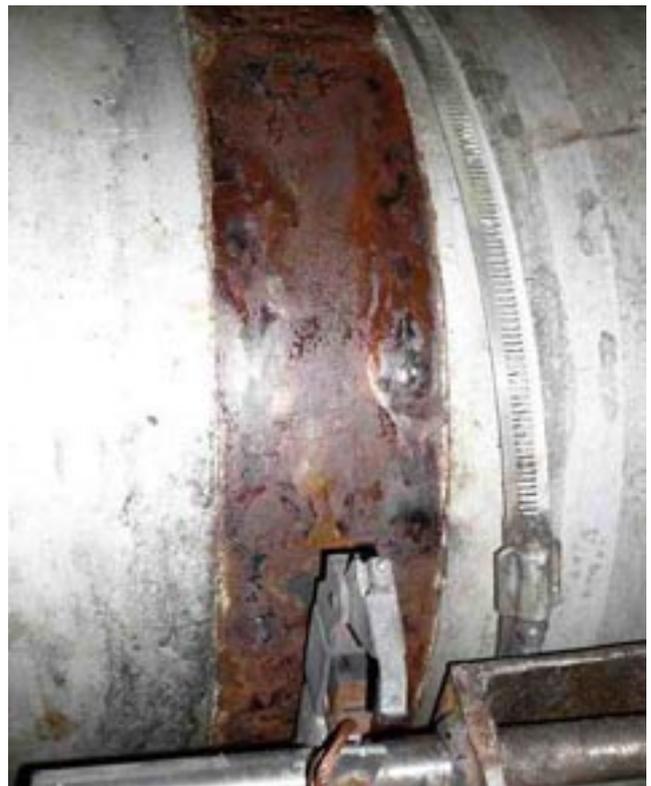
Here, the voltmeter readings were ok, so the shaftline earthing device appeared to be in an acceptable condition.

However: High electrical resistance was measured between the slip ring and the shaft, indicating insufficient electrical contact between slip ring and shaft. Removing the slip ring revealed heavy corrosion on the shaft and on the back side of the slip ring.

Corrosion hiding behind the slip ring

ALWAYS polish the propeller shaft carefully and apply rust protection (e.g. **Dinitrol 300**) between the Ag band and the shaft when assembling and overhauling.

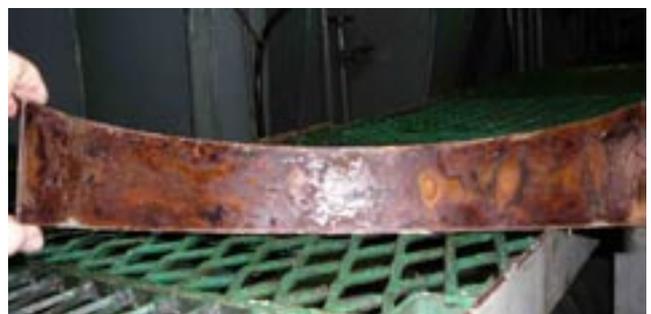
Heavy corrosion on the back side of the slip ring
