Service Letter

SL05-460/NHN
November 2005

Crosshead Bearing Condition
Action Code: AT FIRST OPPORTUNITY

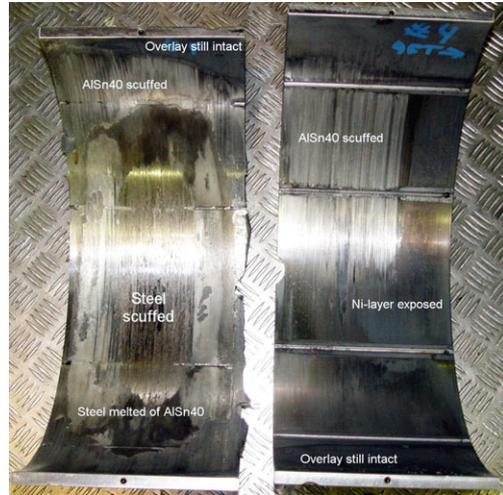
Overlayer completely corroded away, partly scuffing between Ni-layer and pin, partly steel-to-steel contact. **Not acceptable.**

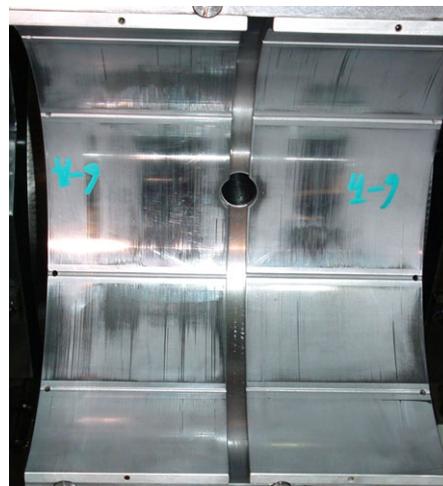
Fully intact overlayer. **Acceptable!**

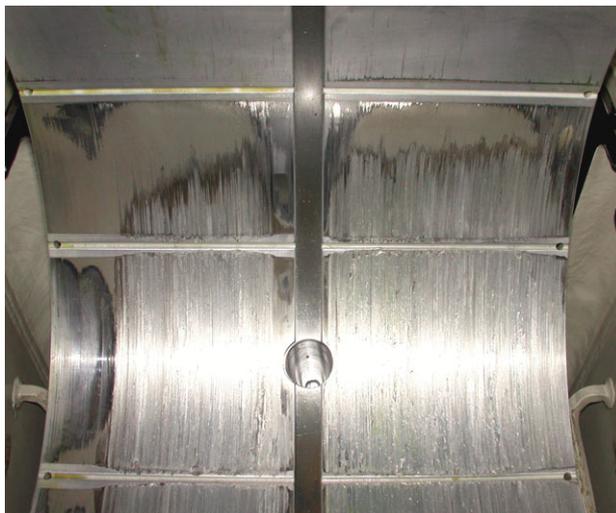
Almost completely corroded-off
overlayer, severe scuffing
between Ni-layer,
AlSn40 lining and XH-pin.

Not acceptable.

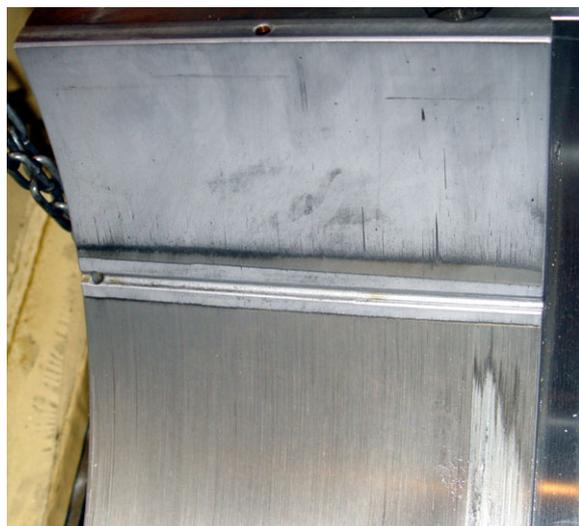
Upper pad: intact overlayer.
Lower pad: 100% exposed Ni.

Not acceptable
